Manhole Inspection Summary

Manhole # S23M__008MH

Insp Date: **6/19/08 12:32 PM**

Location Address: **1639 Wilkens Av**

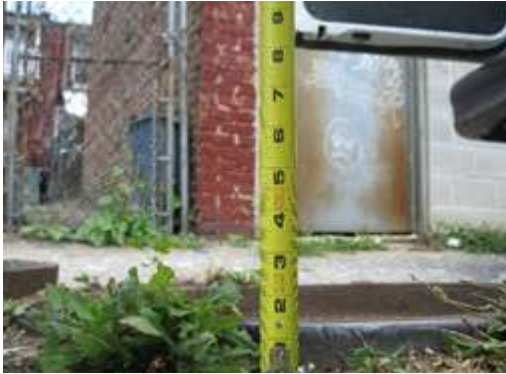
Defect 6

cover above pavement

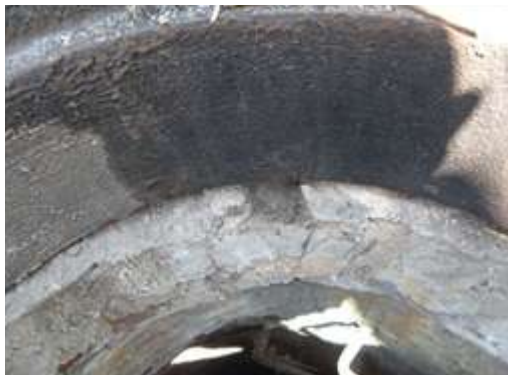
Defect 5

Frame Offset: **0** (in.) Condition: ☐ Sound ☐ Cracked ☒ **Leaks**

lid-frame infiltration

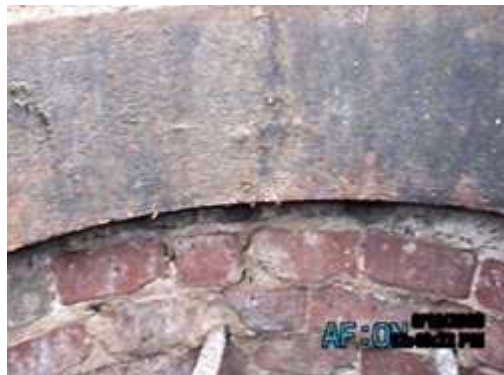
Defect 4

Infiltration: ☐ None ☒ **Joint** ☐ Cracks ☐ Mortar ☐ Roots ☐ Wall

signs of infiltration at chimney joint

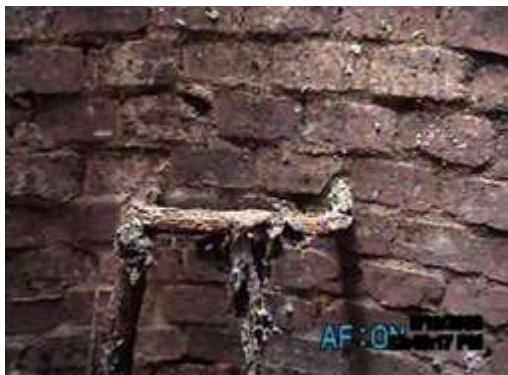
Defect 3

Steps Count: **6** Missing: **0** ☒ **Corroded**

Surcharge ☒ **Evidence Of Surcharge** Depth: **5** (ft.) ☐ Active Surcharge Present

corroded rungs,evidence of surcharge on steps

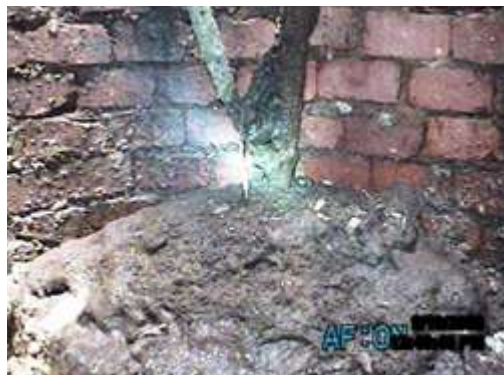
Defect 1

Condition: ☐ Sound ☐ Cracked ☐ Root Intrusion ☐ Deteriorated ☐ Leaks ☒ **Debris**

bench debris

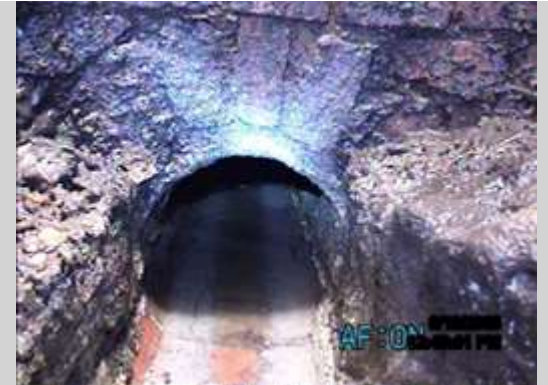
12 O'Clock Outflow

Pipe Height: **8.4** (in.) Rod and Bar (Angled)
Pipe Material: **Clay** ☐ Pipe Lined
Invert Depth: **9.79** (ft.) Flow Characteristics: **Slow**
Deposits: ☒ None ☐ Mud ☐ Sludge ☐ Debris ☐ Grease
Silt Depth: **0** (in.) Deposits Extent:
Infiltration: **Evidence** Pipe Seal Cond: **Unknown**

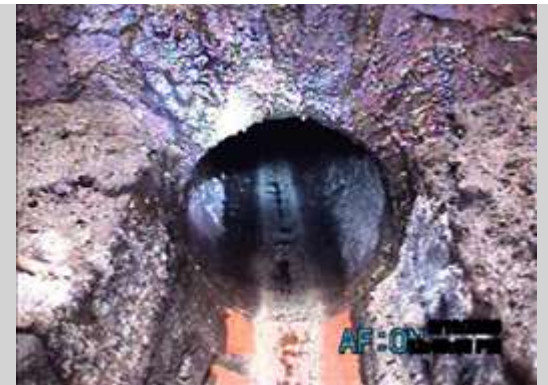
3 O'Clock Inflow

Pipe Height: **8.4** (in.) Rod and Bar (Angled)
Pipe Material: **Clay** ☐ Pipe Lined
Invert Depth: **9.23** (ft.) Flow Characteristics: **Slow**
Deposits: ☒ None ☐ Mud ☐ Sludge ☐ Debris ☐ Grease
Silt Depth: **0** (in.) Deposits Extent:
Infiltration: **Evidence** Pipe Seal Cond: **Unknown**

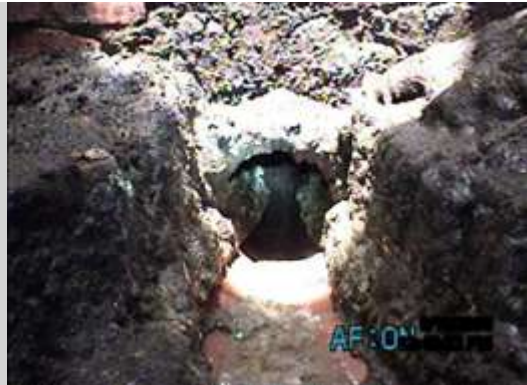
6 O'Clock Inflow

Pipe Height: **8.4** (in.) Rod and Bar (Angled)
Pipe Material: **Clay** ☐ Pipe Lined
Invert Depth: **9.75** (ft.) Flow Characteristics: **Fast**
Deposits: ☒ None ☐ Mud ☐ Sludge ☐ Debris ☐ Grease
Silt Depth: **0** (in.) Deposits Extent:
Infiltration: **Evidence** Pipe Seal Cond: **Unknown**

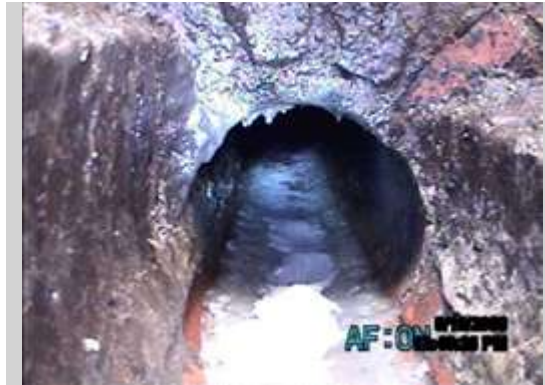
9 O'Clock Inflow

Pipe Height: **8.4** (in.) Rod and Bar (Angled)
Pipe Material: **Clay** ☐ Pipe Lined
Invert Depth: **9.62** (ft.) Flow Characteristics: **Slow**
Deposits: ☒ None ☐ Mud ☐ Sludge ☐ Debris ☐ Grease
Silt Depth: **0** (in.) Deposits Extent:
Infiltration: **Evidence** Pipe Seal Cond: **Unknown**
